**FEDERAL AVIATION ADMINISTRATION
AIRWORTHINESS DIRECTIVES
SMALL AIRCRAFT, ROTORCRAFT, GLIDERS,
BALLOONS, & AIRSHIPS**

BIWEEKLY 2000-12

2000-11-04 COMMANDER AIRCRAFT COMPANY: Amendment 39-11752; Docket No. 99-CE-81-AD.

2000-11-05 AIR TRACTOR INCORPORATED: Amendment 39-11753; Docket No. 2000-CE-21-AD.

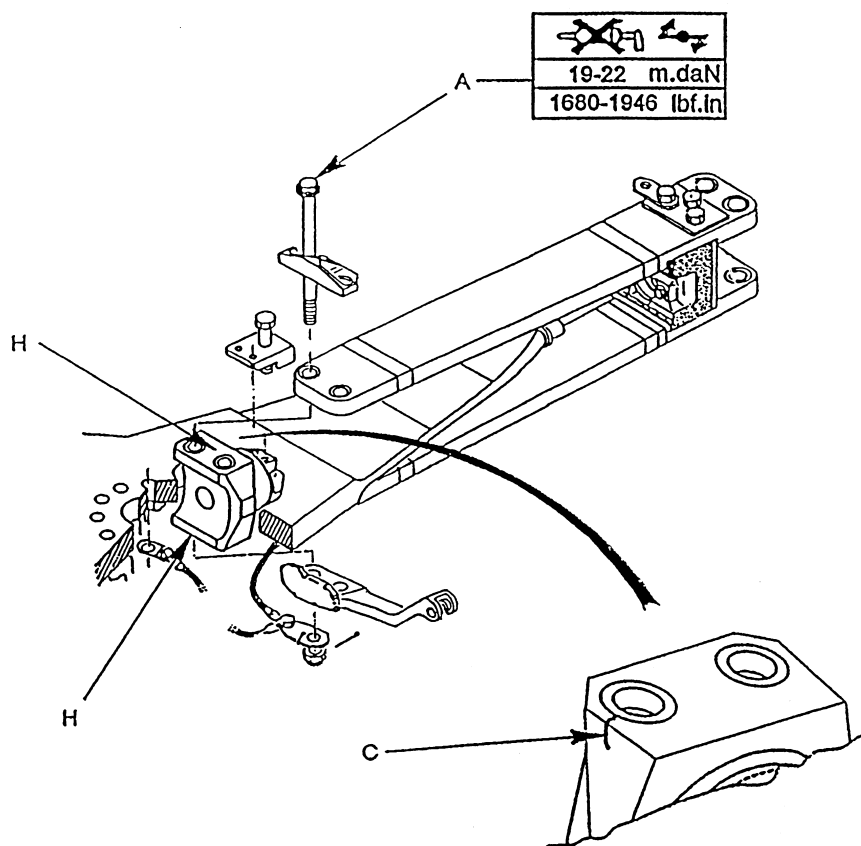
FIGURE 1

To prevent loosening of the main rotor hub blade attach beam spherical thrust bearing bolts (bolts), cracks in the metal components, failure of a spherical thrust bearing (bearing), and subsequent loss of control of the helicopter, accomplish the following:

(1) If tightening torque is equal to or less than 12 m.daN (88.4 lb-ft), remove the bearing and conduct a dye penetrant inspection for cracks on the two contact surfaces identified as "H" in Figure 1.

(i) If a crack is detected, replace the bearing with an airworthy bearing.

(ii) If no crack is detected, reinstall the bearing.
